# Manhole Inspection Summary

Manhole # S13OO1013MH

Insp Date: **11/29/06 10:42 AM**

**Location** Address: **4804 POE AVE**

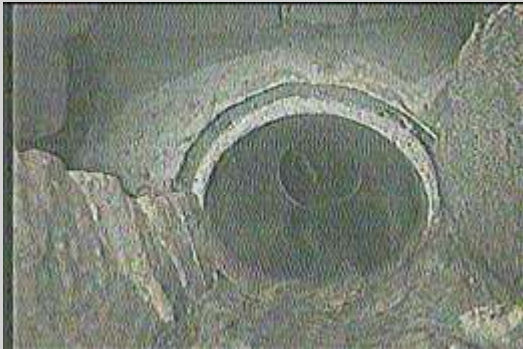
### 8 in. Circular Gravity Sewer Pipe Out @ 12 O'Clock

Rod and Bar (Angled)

Pipe Material: **Clay** ☐ Pipe Lined

Infiltration: **None** Pipe Seal Cond: **Unknown**
